Kingston City Council  
and  
Better Bays and Waterways -  
Institutionalising Water Sensitive  
Urban Design and Best Practice  
Management Project

# Review of Street Scale WSUD in Melbourne

## Study Findings

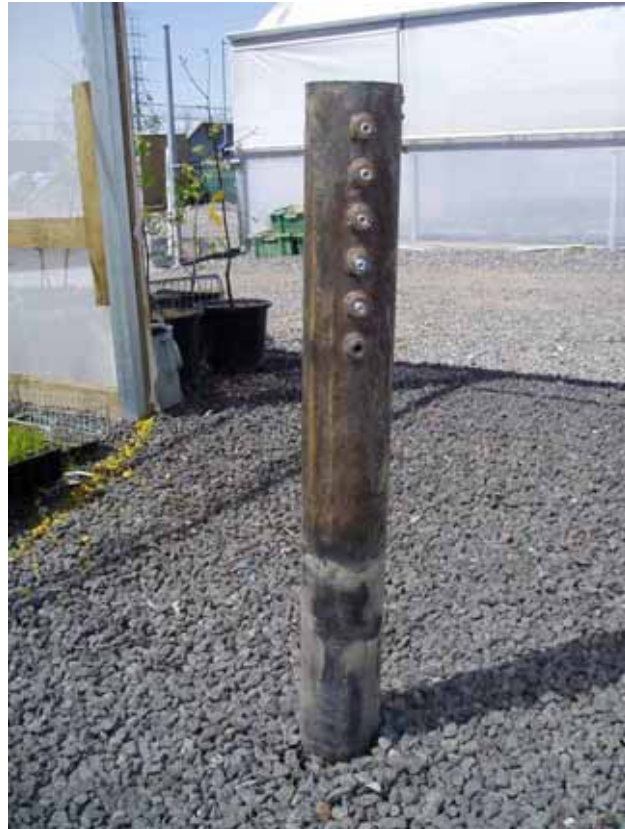
**Figure 2-1 Infiltration rate test rig**

The in-situ test method used a steel collar that was driven into the filter profile to the drainage layer. A constant head was maintained within the steel tube and topped up on a regular basis, with the timing and volumes of additions recorded. The head used for the test was matched to the operating head of the rain garden, i.e. the test water level was equivalent to the maximum extended detention depth. Tests were run for between 1 and 2 hours depending on the infiltration rate, with tests suspended early when infiltration rates were low, i.e. less than 10mm/hour. The tests were conducted by Land and Water Constructions and the Facility for Advanced Water Biofiltration (FAWB) with results pooled.

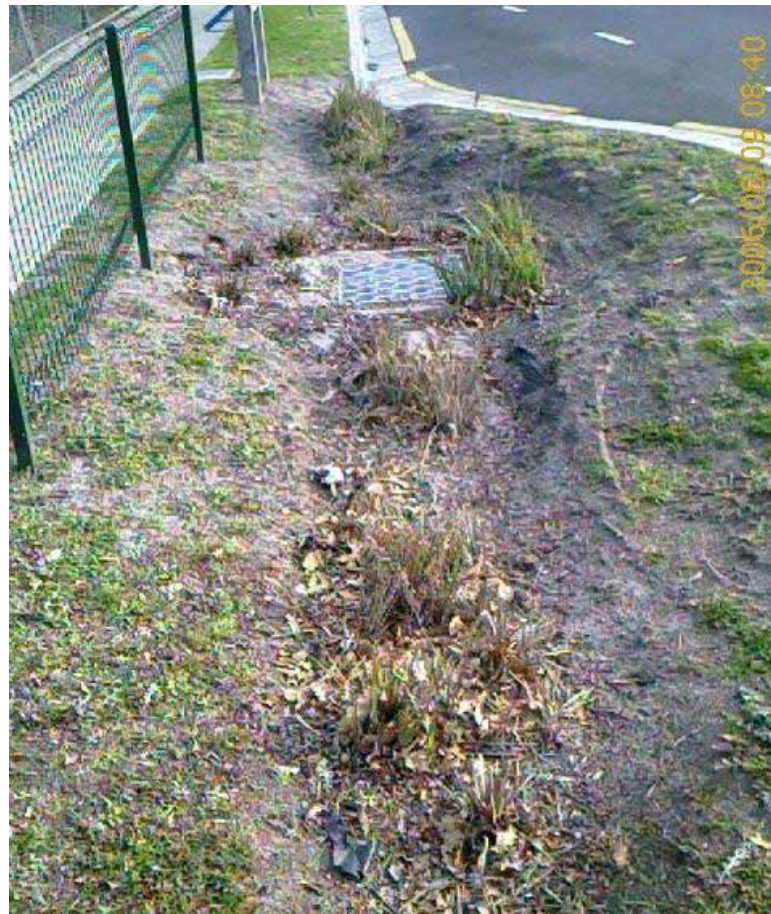
In a number of cases, rain gardens have suffered from being in pedestrian or traffic paths. For example the rain garden in Figure 3-1 is located in front of a school in an area of high foot traffic. Despite being fenced, pedestrians walk across the rain garden, eroding the surface and compacting the filter media. In another example, the rain gardens in Cremorne Street, Richmond (Figure 3-2) have been fenced to separate pedestrians and traffic from the rain garden areas. Damage to the fences by accidents and vandalism however, reduce the aesthetics significantly.

**Figure 3-1 A rain garden in front of a school suffering damage from pedestrian traffic, Fowler Street, Bonbeach**

A number of design actions can be undertaken to reduce conflicts between pedestrians or traffic and rain gardens. Simple measures include clear delineation of the bed via methods such as mulch and edge strips. These measures clearly define the rain garden as different from the surrounding area and discourage access. Vegetation can also be successfully used to create a barrier that discourages entry and defines the space. It was observed that many of these measures had been implemented on more recent projects. For example, Kingston City Council rain gardens have moved from systems such as Figure 3-1 where the treatment element was placed within a conventional nature strip, to a standard design that includes features such as mulch and edge strips. The newer systems also tend to be larger with batter areas and grade changes incorporated into the bed. Alleyne Avenue is a good example of this approach (Figure 3-3).

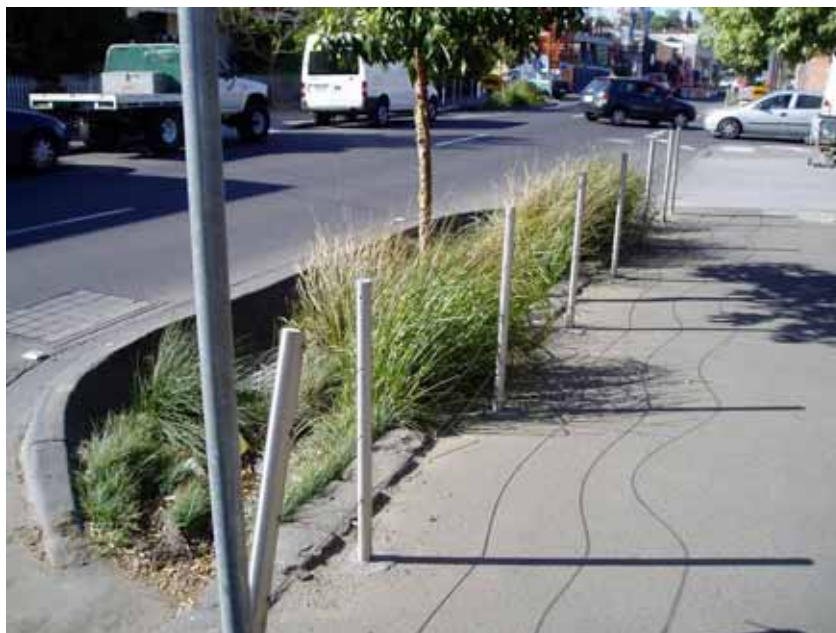
**Figure 3-2 Damage to fences, Cremorne Street, Richmond**

A concern with the use of hard edges is the management of trip hazards. As discussed earlier, it is necessary to take up grade changes of up to 400mm across a rain garden. The treatment of these grade changes varies, with some examples, such as Cremorne Street, taking up grade changes in a single step and using fencing as edge protection. A disadvantage of the use of fences in urban environments is the resulting maintenance load created by vandalism and accidental damage, with many of the fences at Cremorne Street exhibiting damage.

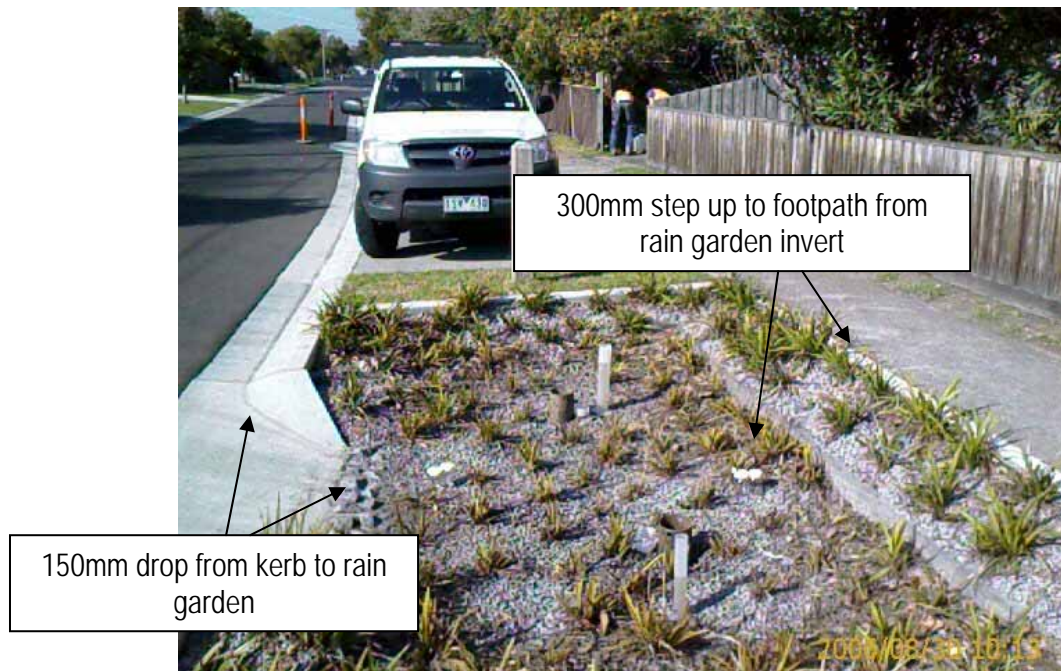
**Figure 3-3 An example of the grade change to be accommodated across a rain garden, Alleyne Avenue, Chelsea**

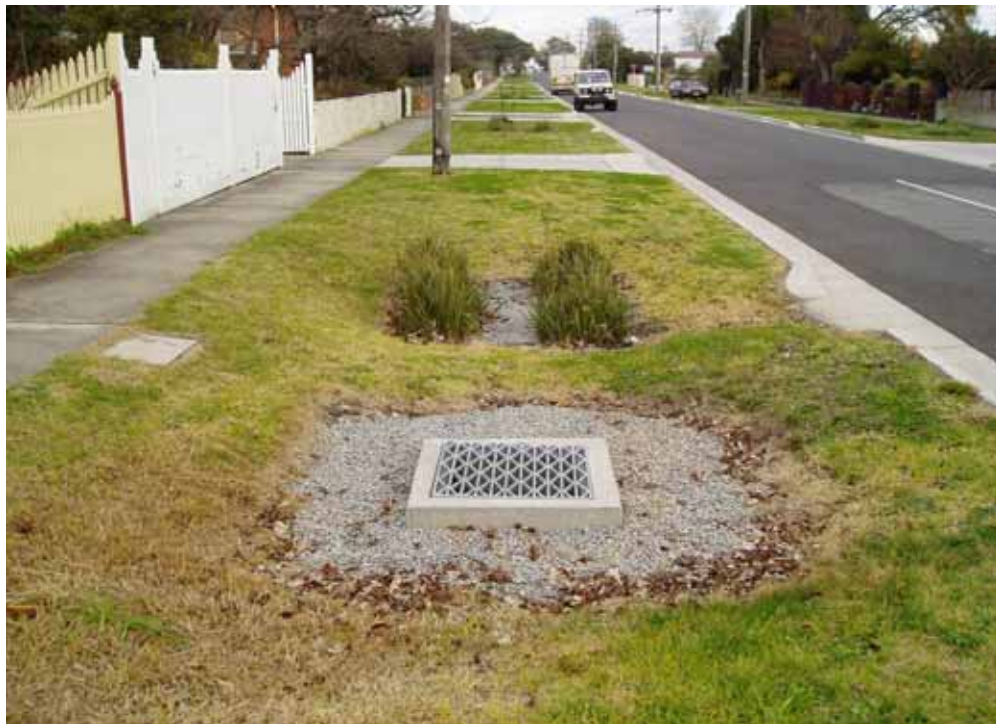
There are two methods to address the level difference, i.e. to use a sloping batter or construct hard vertical edges. Figure 3-4 and 3-5 provide examples of two treatments where sloping batters are used. The batters can be grassed, planted or paved. Issues observed with battered treatments are summarised as follows:

**Figure 3-4 Grassed batters within a rain garden, Riviera Street, Mentone**

These issues can be addressed through raised barriers or flat buffer strips (minimum width 300mm) adjacent to pedestrian paths. The buffer strip provides separation of pedestrians from the batter and allows an area for plants to be grown to further delineate the edge.

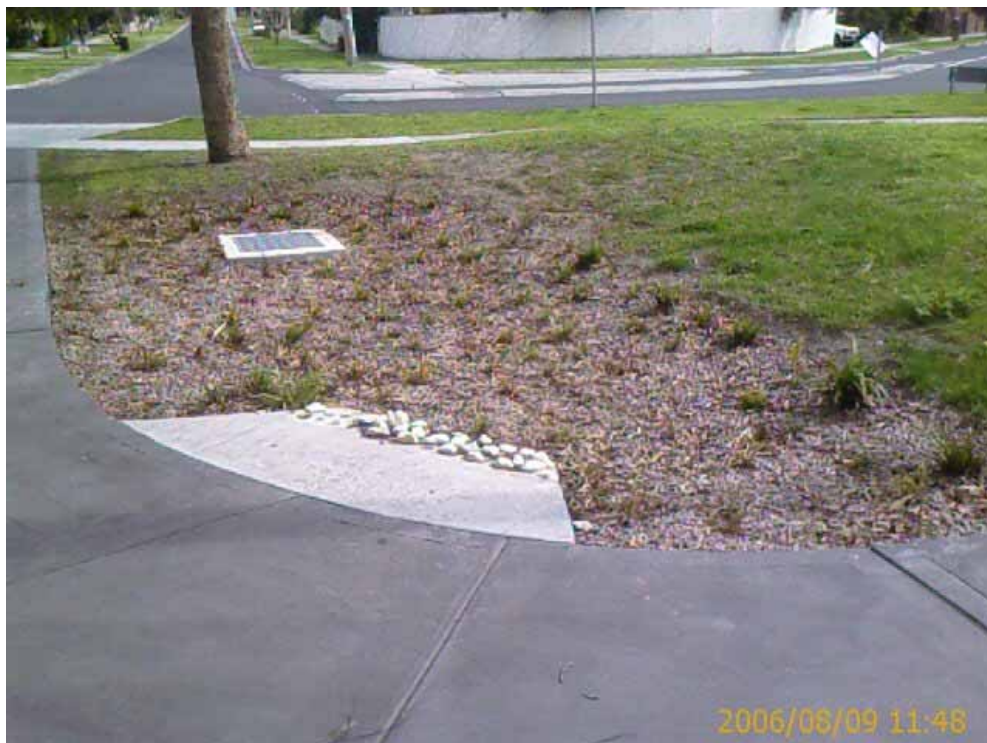
**Figure 3-5 Mulched and planted batters, Voltri Street, Cheltenham**

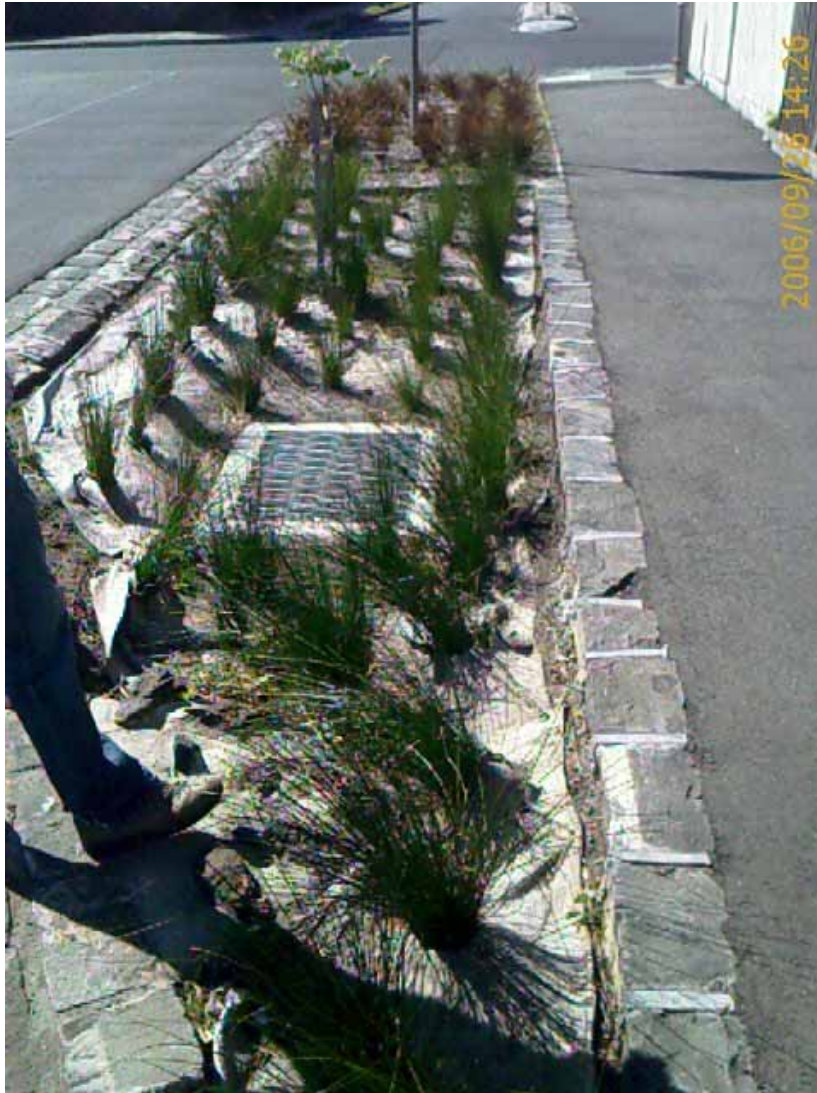
- Timber retaining walls, Figure 3-3;
- Bluestone and paving, Figure 3-6; and
- Concrete edge beam, Figure 3-7.

**Figure 3-6 Rain garden with a blue stone edge, Hamilton Street, Brunswick West**

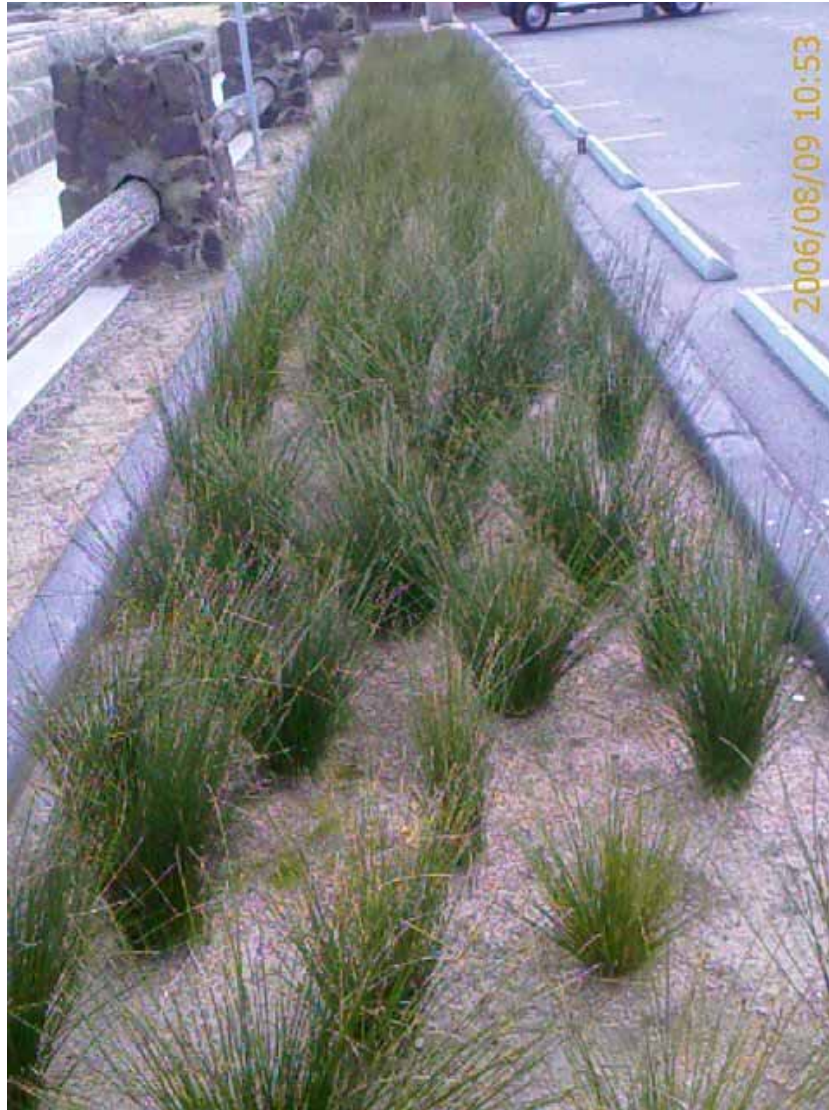
**Figure 3-7 Rain garden with concrete edge beam, Ricketts Point, Beaumaris**

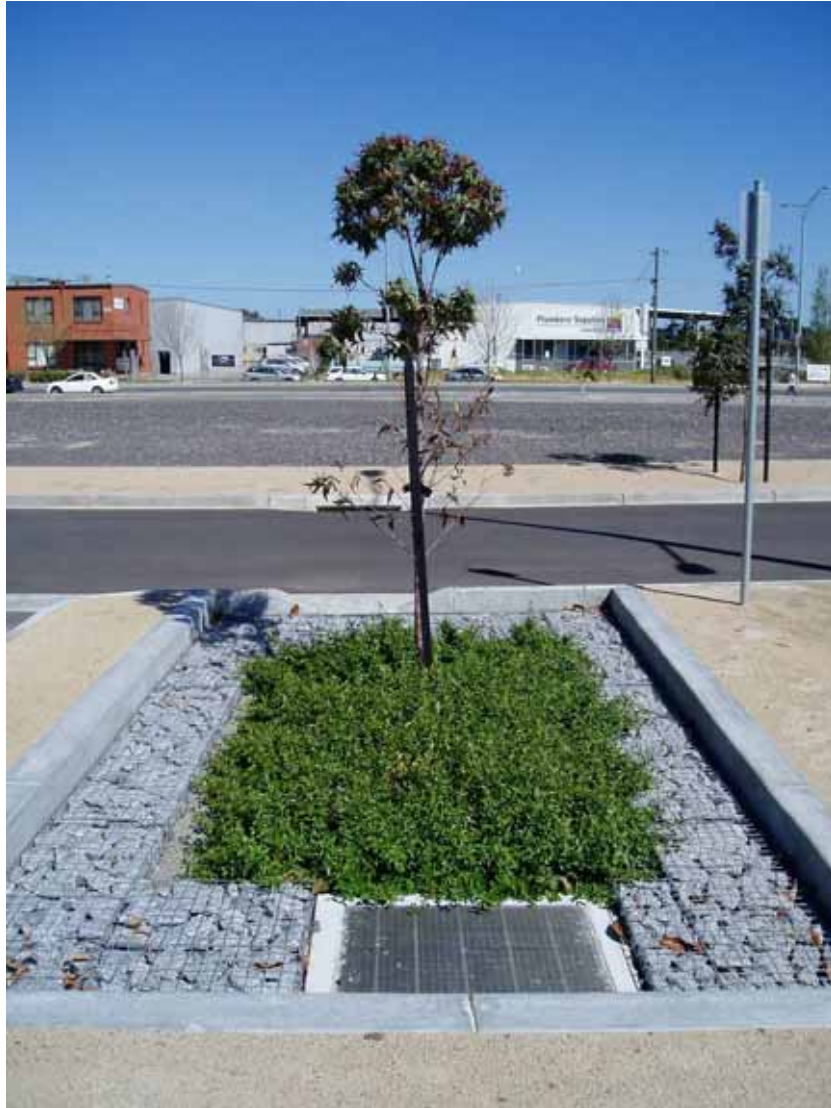
Other sites take up the grade change in one or more steps, e.g. Point Park car park. The Point Park car park (Figure 3-8) uses a concrete edge beam and a gabion basket to take up a grade change of approximately 200mm. This approach is considered to be very successful as the grade change is incorporated into the design and it provides no greater risk than the surrounding streetscape. The Point Park car park site has a large footprint due to the width of the gabion, a smaller footprint may be achieved by limiting the step tread to a minimum width of 200mm.

**Figure 3-8 Edge details at Point Park car park, Docklands**

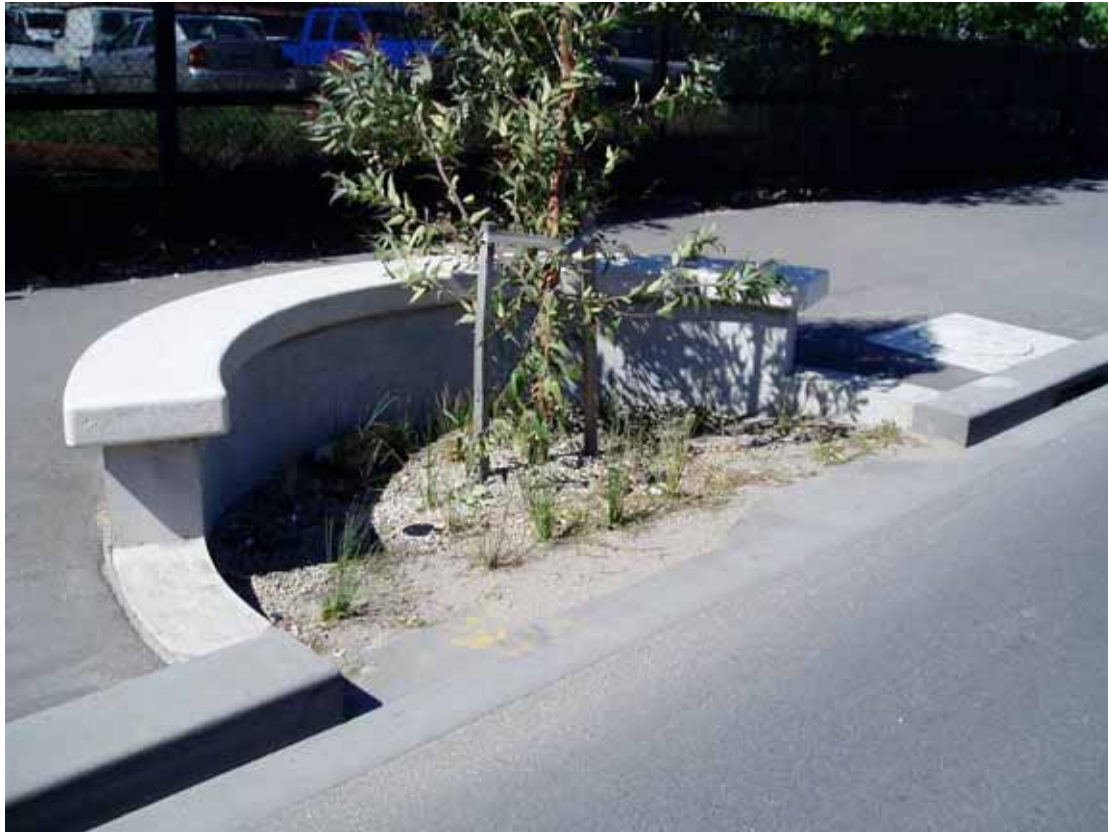
The final method reviewed to protect rain garden edges is the use of street furniture. The street tree biopits in the Docklands precinct provide a good example of this type of treatment, Figure 3-9.

**Figure 3-9 Seating used to accommodate the grade change at a rain garden, Docklands**

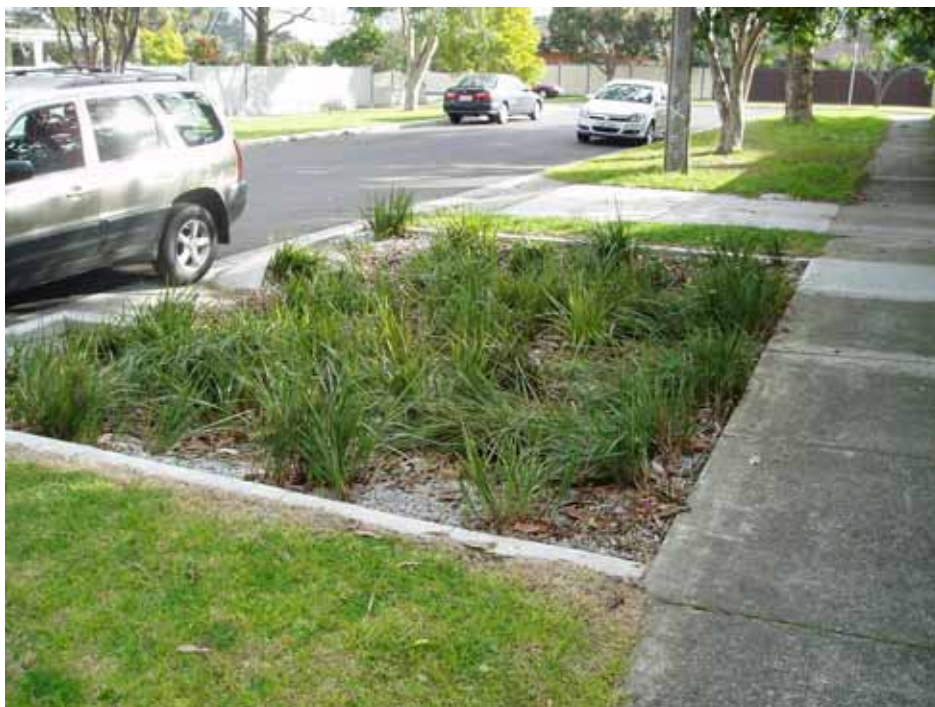
A range of edge treatments have been adopted across the sites that were reviewed. Many of the edge treatments are integral to the geometry of the system and have been discussed previously. Edge strips are also provided to delineate the rain gardens from the surrounding landscape, in particular grassed areas. Kingston City Council uses concrete edge strips in newer systems to facilitate maintenance. The strips provide an edge along which weeds and grass can be controlled and delineate areas maintained by Council. If the rain garden is to be located within a grassed area it is recommended that edge strips be adopted to facilitate maintenance. Figure 3-10 provides an example of an edge strip used to delineate a garden bed. As discussed earlier, edge strips also delineate the bed indicating to the public that it is different to surrounding landscape.

**Figure 3-10 Concrete edge strip used to delineate a rain garden, Stawell Street, Mentone**

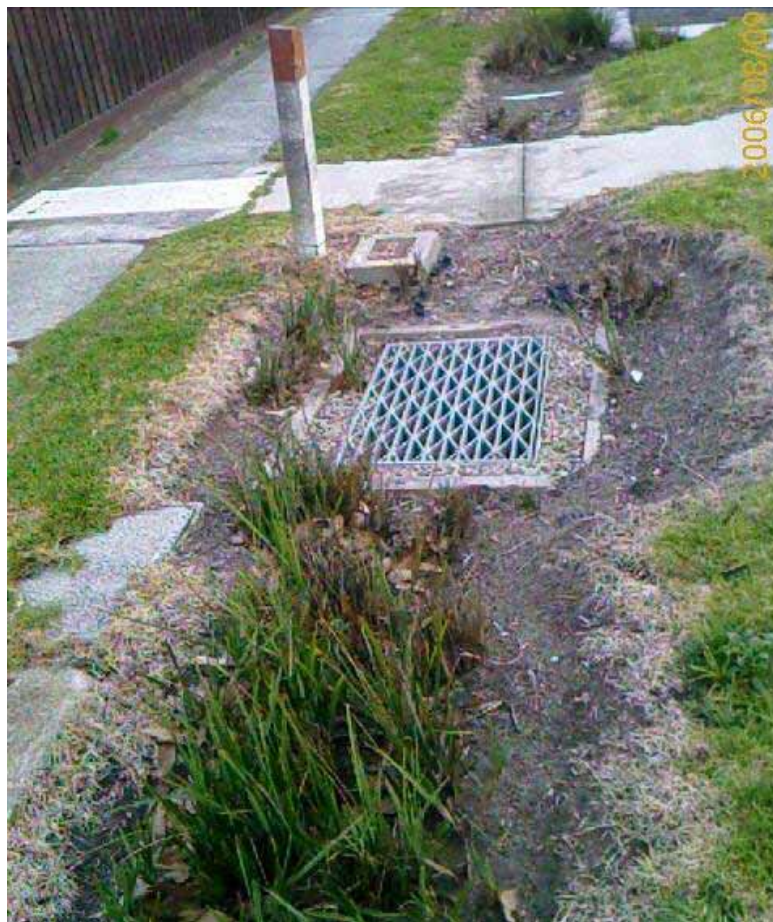
In systems where landscape beds are not delineated from the surrounding landscape it was often observed that maintenance of the rain garden was compromised. For example at a number of Kingston sites, e.g. Fowler Street and Riviera Street, rain gardens are located within grassed nature strips with no edge strip. At each of these sites management of the rain garden vegetation is compromised as the surrounding grass is growing into the garden bed requiring control by trimming and herbicide. Figure 3-11 shows an example of where herbicide control of the grassed areas has resulted in overspray of the rain garden vegetation, the creation of unsightly bare areas and damage to the rain garden vegetation.

**Figure 3-11 An example of the lack of edge strip and the effects of maintenance to keep grass clear of rain garden**

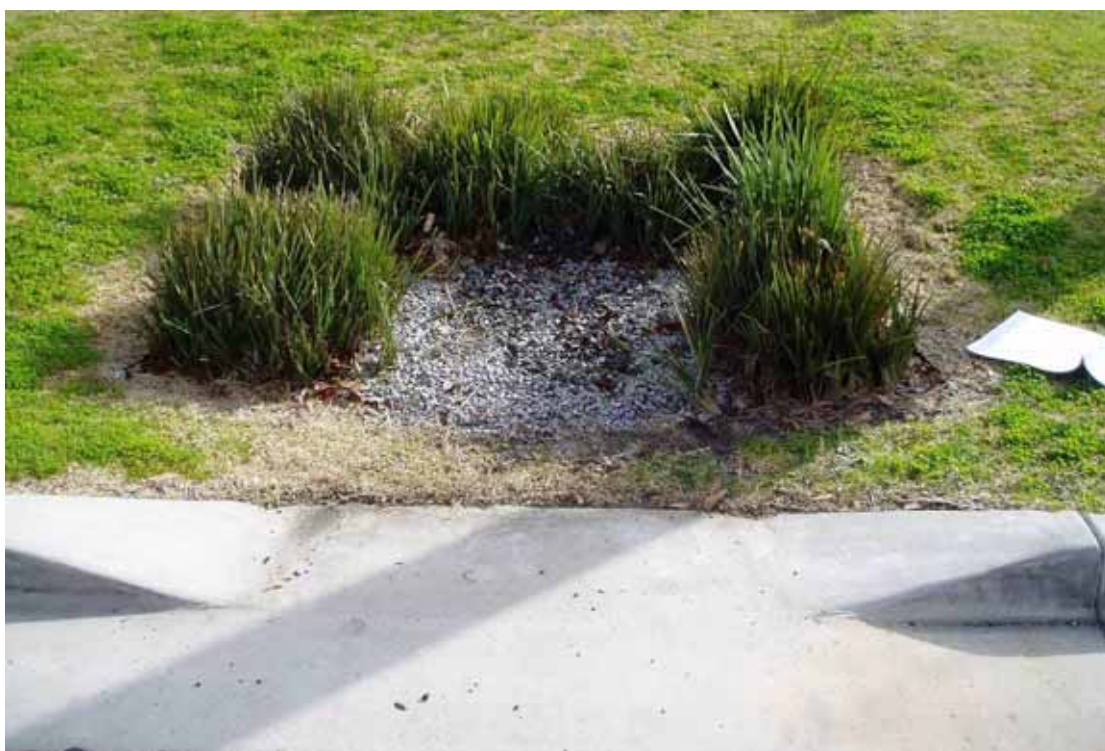
In older systems, filter media was usually defined in terms of a particle size grading alone and the systems appeared to be constructed in accordance with the design. The high degree of compliance between the design and as-built details, reflects the simplicity of the designs. An example of this type of system is shown in Figure 3-12. In some of these systems, e.g. Doncaster Park and Ride, the filter media is wrapped in geofabric. Since this system was constructed, it has been demonstrated that a geofabric layer within the filter is likely to clog over time, reducing the system's infiltrative capacity. Older systems that have been constructed in this manner will require monitoring to determine their infiltrative capacity and may require remedial works, i.e. re-setting of the filter.

**Figure 3-12 A single layer system that includes an area where the planter bed has been inserted, Riviera Street, Mentone**

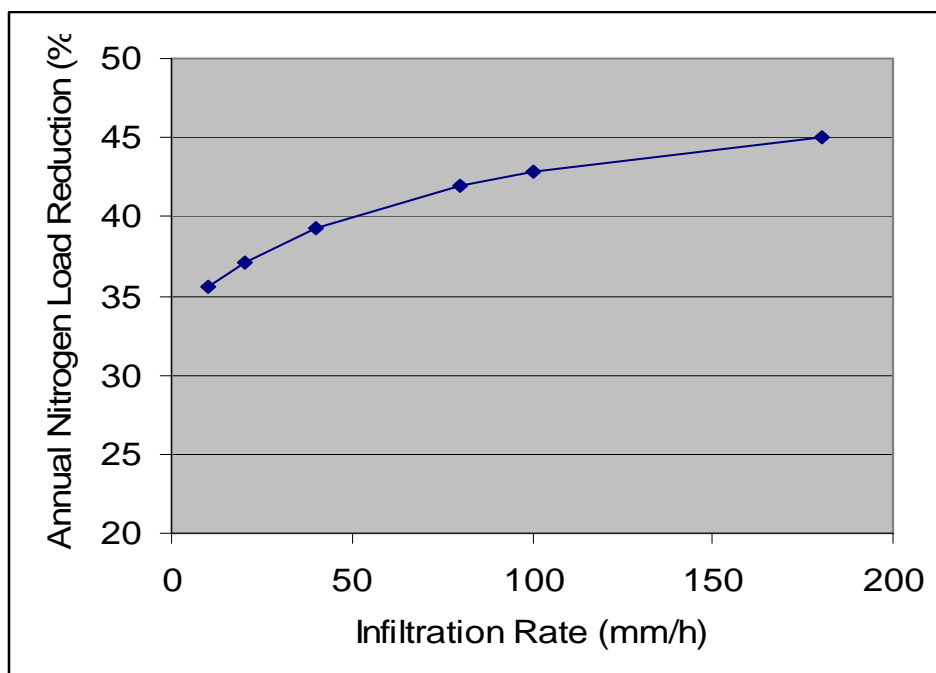
The effect of infiltration rate on pollutant removal is demonstrated in Figure 3-14, which plots the nitrogen removal estimate from a simulation of a rain garden performance with a range of infiltration rates. Simulations were undertaken using the Model for Urban Stormwater Conceptualisation (MUSIC). In this example, the rain garden was designed to meet best practice with an infiltration rate of 180mm/h. The infiltration rate was then varied to quantify its impact on pollutant removal. As the infiltration rate decreases, the proportion of nitrogen removal decreases, this is largely due to the increased rate of bypass as a result of decreased infiltration. The results suggest that many of the rain gardens reviewed in this study, which have lower than specified infiltration rates, would have the design pollutant removal effectiveness reduced by 10 to 15%.

**Figure 3-14 Effect of infiltration rate on rain garden performance as indicated from MUSIC modelling results**

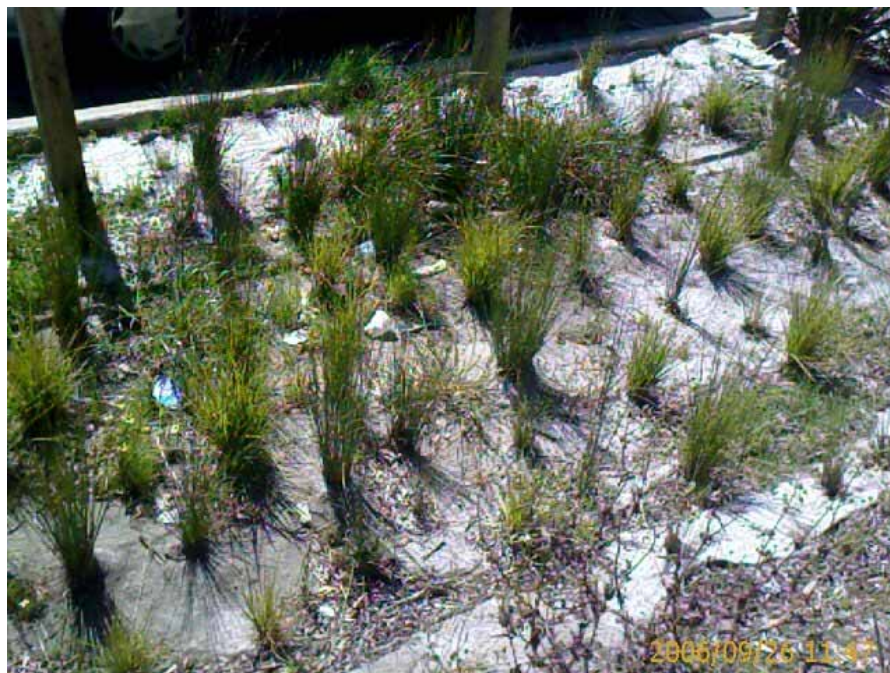
Jute mat was used in a number of cases and provides effective cover in the short term. Over the longer term its effectiveness is questionable as it degrades over a three to five year period. The impact of jute on infiltration rates is not well understood, with concerns raised over its ability to maintain sufficient hydraulic conductivity to ensure the filter receives adequate flow. Research is required to determine the effective infiltrative capacity of jute mat and its variability over time.

**Figure 3-15 An example of jute mat that has been laid for 18 months**

The effective life of jute mat is considered to be less than 5 years, however at the end of this period plants should have sufficient coverage to no longer need the matting as mulch. Jute mat has the disadvantage of potentially being perceived as unsightly in the early years, prior to good plant coverage being achieved. This perception arises as the jute can be lifted at the edges due to plant growth and the colour of the material is distinctive and fades over time (Figure 3-15). If jute mat is to be used, the plant list should include ground cover species that will cover the jute mat, creating a self mulching organic layer. Recommendations of suitable groundcover species are contained in Section 4.4.

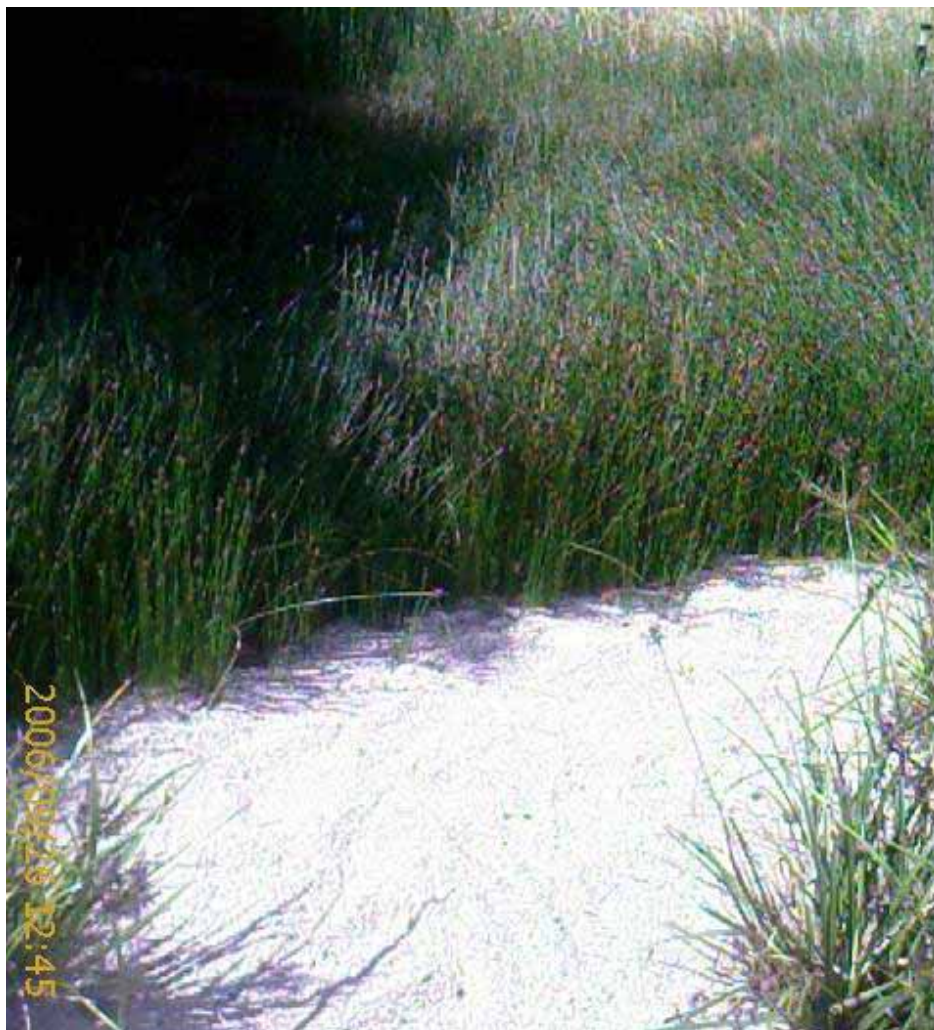
The depth of stone mulch was variable with depths within the range of 50mm to 75mm considered appropriate. The grading of the material impacts the required layer thickness, with finer materials requiring thinner layers. Systems should be designed to have the appropriate extended detention depth of 100 – 200mm accommodated above the mulch layer.

**Figure 3-16 An example of fine gravel mulch, Inkerman D’Lux, St Kilda**

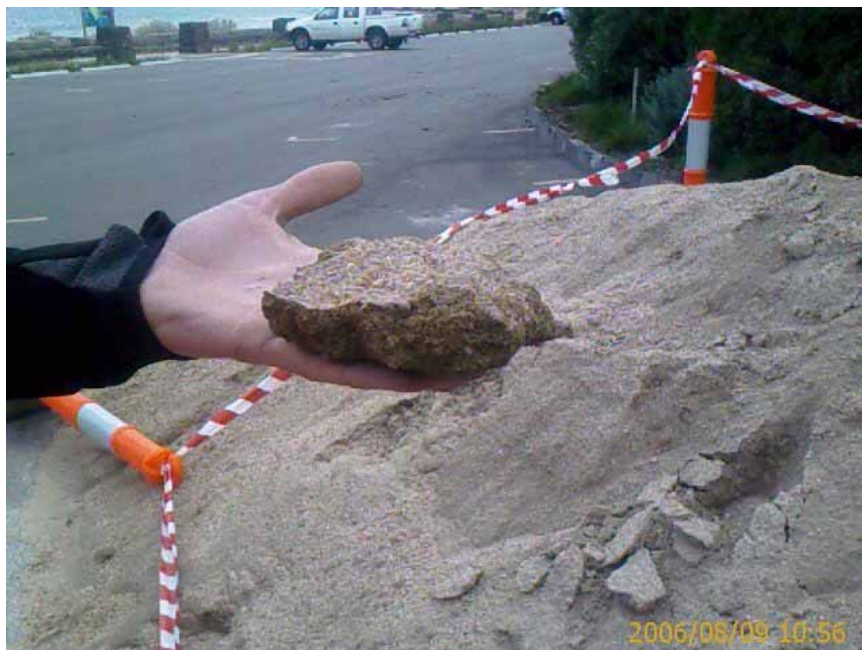
The impact of using inappropriate gravel is demonstrated in Figure 3-17, which outlines the results from an infiltration test conducted at Ricketts Point. The infiltration tests shown in Figure 3-17 were conducted with the mulch in place and removed. Where the mulch is in place the measured infiltration rate was an order of magnitude lower than where it was removed. The biofiltration swale at Ricketts Point has been mulched with a granitic sand material, which is frequently used in the construction of paths. Figure 3-18 shows a sample of granitic sand and demonstrates its structural integrity.

**Figure 3-18 A sample of granitic sand, demonstrating its structural properties**

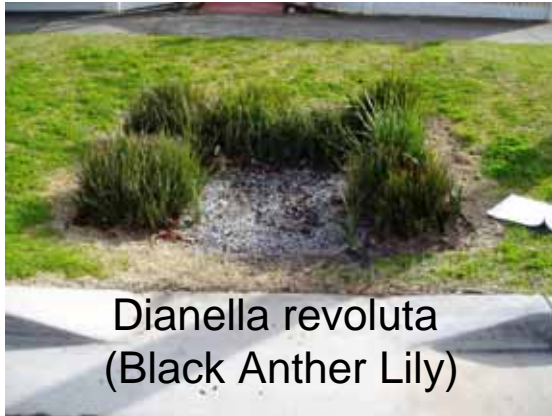
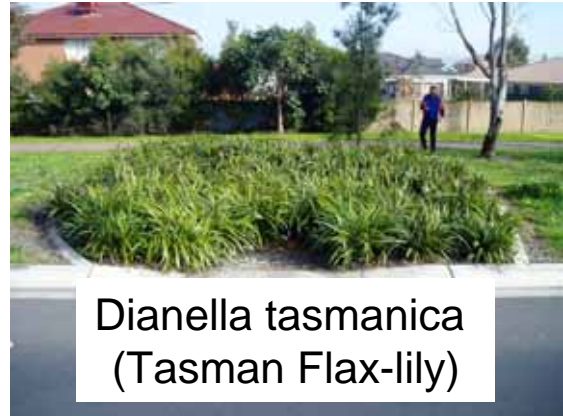
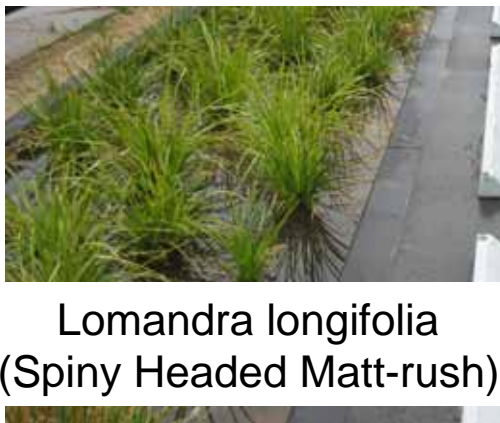
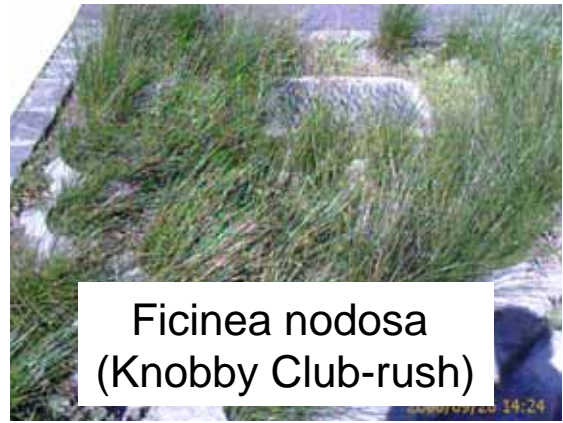
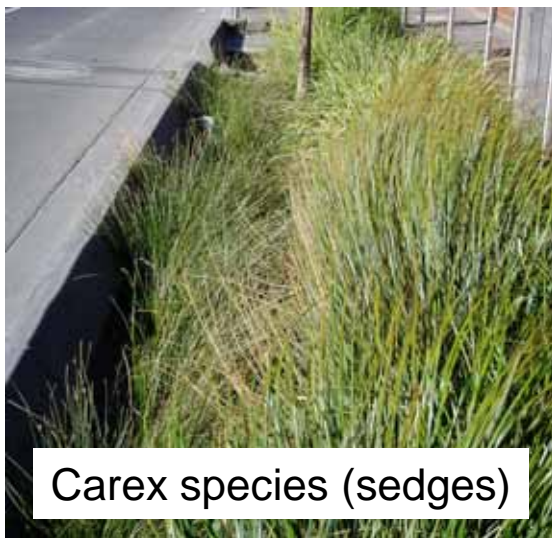
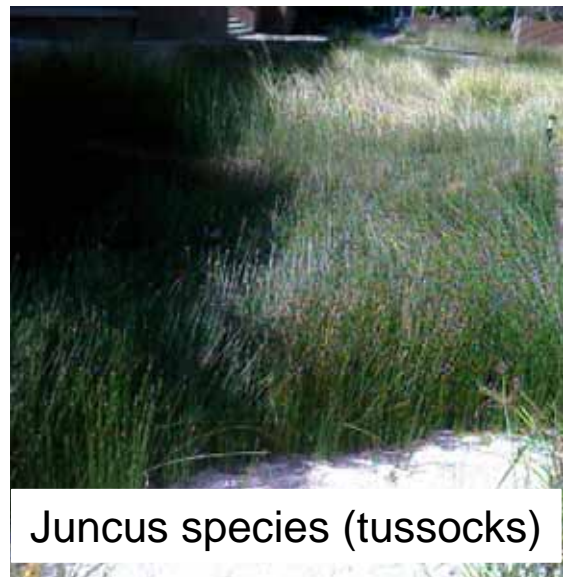
**Figure 3-19** Examples of plants commonly used in rain gardens

An example of each of the plants is outlined in Figure 3-19.

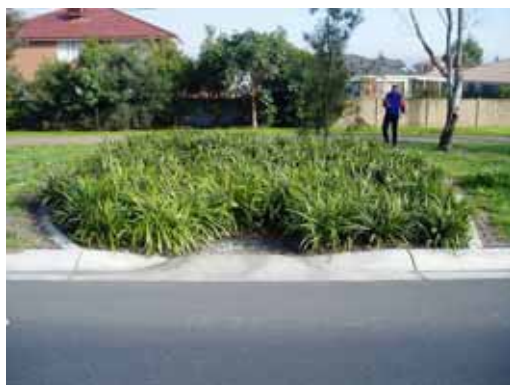
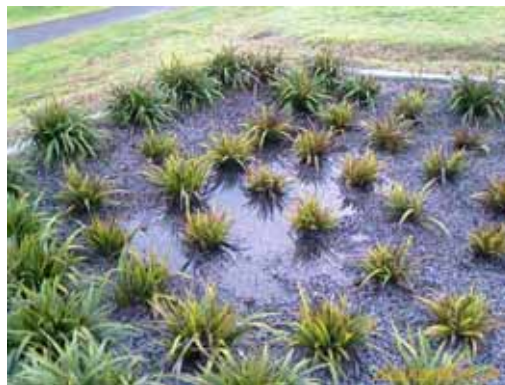
For example, Wells Road contains five rain gardens, four of which have healthy stands of *Dianella tasmanica* and one with poor vegetation (refer Figure 3-20). The beds with healthy growth had infiltration rates of 87mm/h and 136mm/h respectively. The bed with poor growth had an infiltration rate of 5mm/h and 19mm/h, indicating it was likely to be water logged. Similar results were also found at Alleyne Avenue and Stawell Street. These results reflect the experience of the authors with *Dianella* species in a range of applications, which has shown that *Dianella* species prefer well drained environments.

**Figure 3-20 Examples of well (a) and poorly (b) performing rain gardens planted with *Dianella tasmanica*, Wells Road, Chelsea Heights**

Based on these results, it is an advantage to use some plants in the planting list that exhibit visible distress when planted in saturated conditions. If plants die or exhibit poor health when the filter is saturated, i.e. it has low hydraulic conductivity, it is likely to prompt investigations to determine why the plants are growing poorly. This was the case at Wells Road where one filter had a very low infiltration rate resulting in poor plant growth, the poor plant growth prompted investigation which revealed the filter was clogged. Use of species adapted to growing in wet conditions, e.g. juncus species, will not provide a method of indicating poor plant growth.

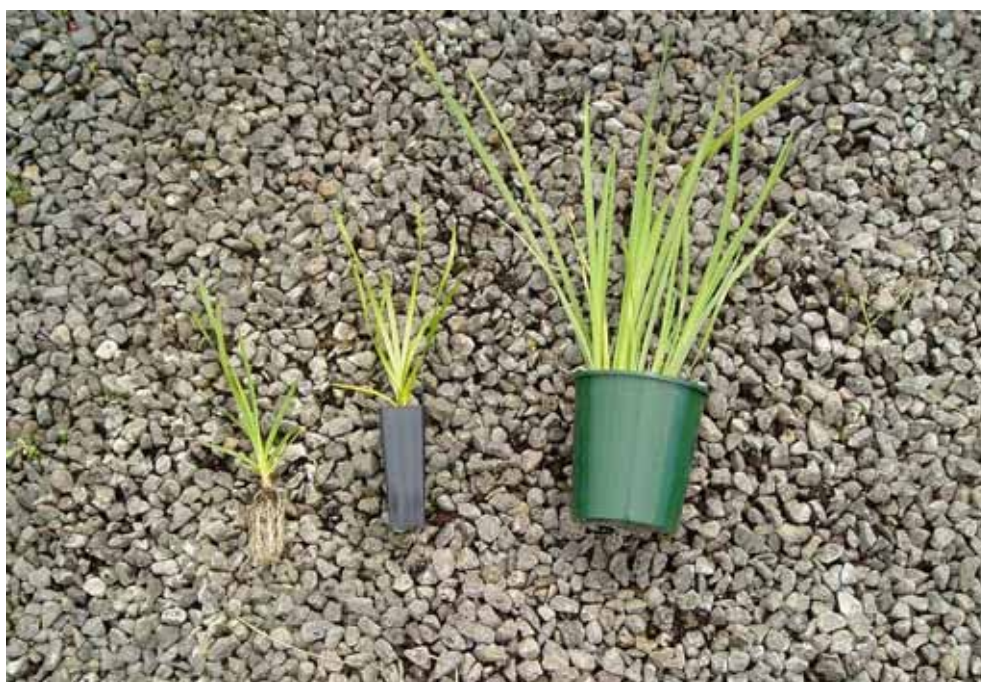
A range of plant formats are used to establish rain gardens, the most common formats being 150mm pots and tube stock. Figure 3-21 shows an example of a hiko tube, forestry tube and 150mm pot. The 150mm pot is significantly larger, with both greater shoot and root growth. Larger stock is typically used to provide an immediate impact at the time of construction. In the long term, there is no difference in the mature size of plants regardless of their container size at planting. The use of 150mm stock will typically reduce the plant establishment period by 12 months. The reduced plant establishment period comes at an increased maintenance cost as larger plants suffer a greater degree of transplant shock and will require more frequent watering. Larger plants are also more expensive, an issue which is explored in Section 4. It may be appropriate to use 150mm stock for border planting and tube stock within gardens.

**Figure 3-21 A comparison of a hiko tube, forestry tube and 150mm container-grown plant**

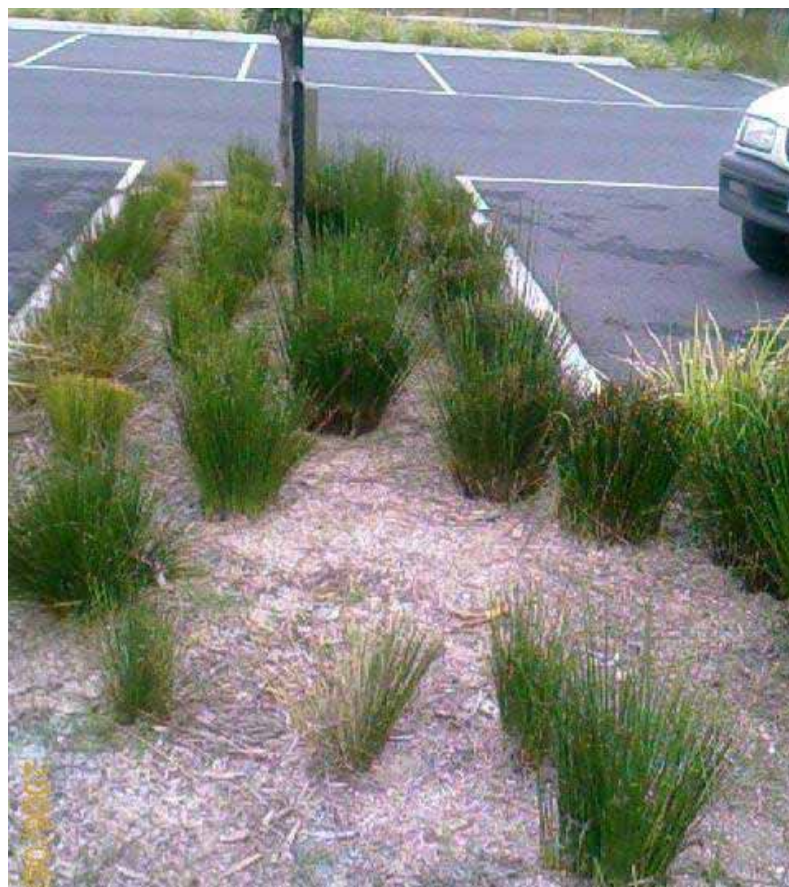
Inappropriate maintenance of the vegetation had resulted in damage to plants and plant deaths in some cases. The most common form of maintenance damage was excessive trimming of plants (Figure 3-22). Whilst some plants, such as the poa species, require regular trimming and de-thatching to maintain vigour, most do not. It is recommended that the condition of the plants be monitored and they be cut back and de-thatched when they have built up large quantities of dead organic material. Other than poas, it is unlikely that the most common suite of plants used as described in section 3.6.2 would require trimming in the first 5 years of their life and in many cases it would be more than 10 years.

**Figure 3-22 An example of plants that have been trimmed excessively**
